Report Verification

This Arboricultural Impact Assessment was commissioned by Labosport Limited to accompany a planning application for development at Forest Hill School, London. A survey of the trees on site and within influencing distance of the boundaries was undertaken on the 5th of February 2025 as part of a Preliminary Arboricultural Assessment to aid design and avoid unnecessary tree removal.

C181796-01-01

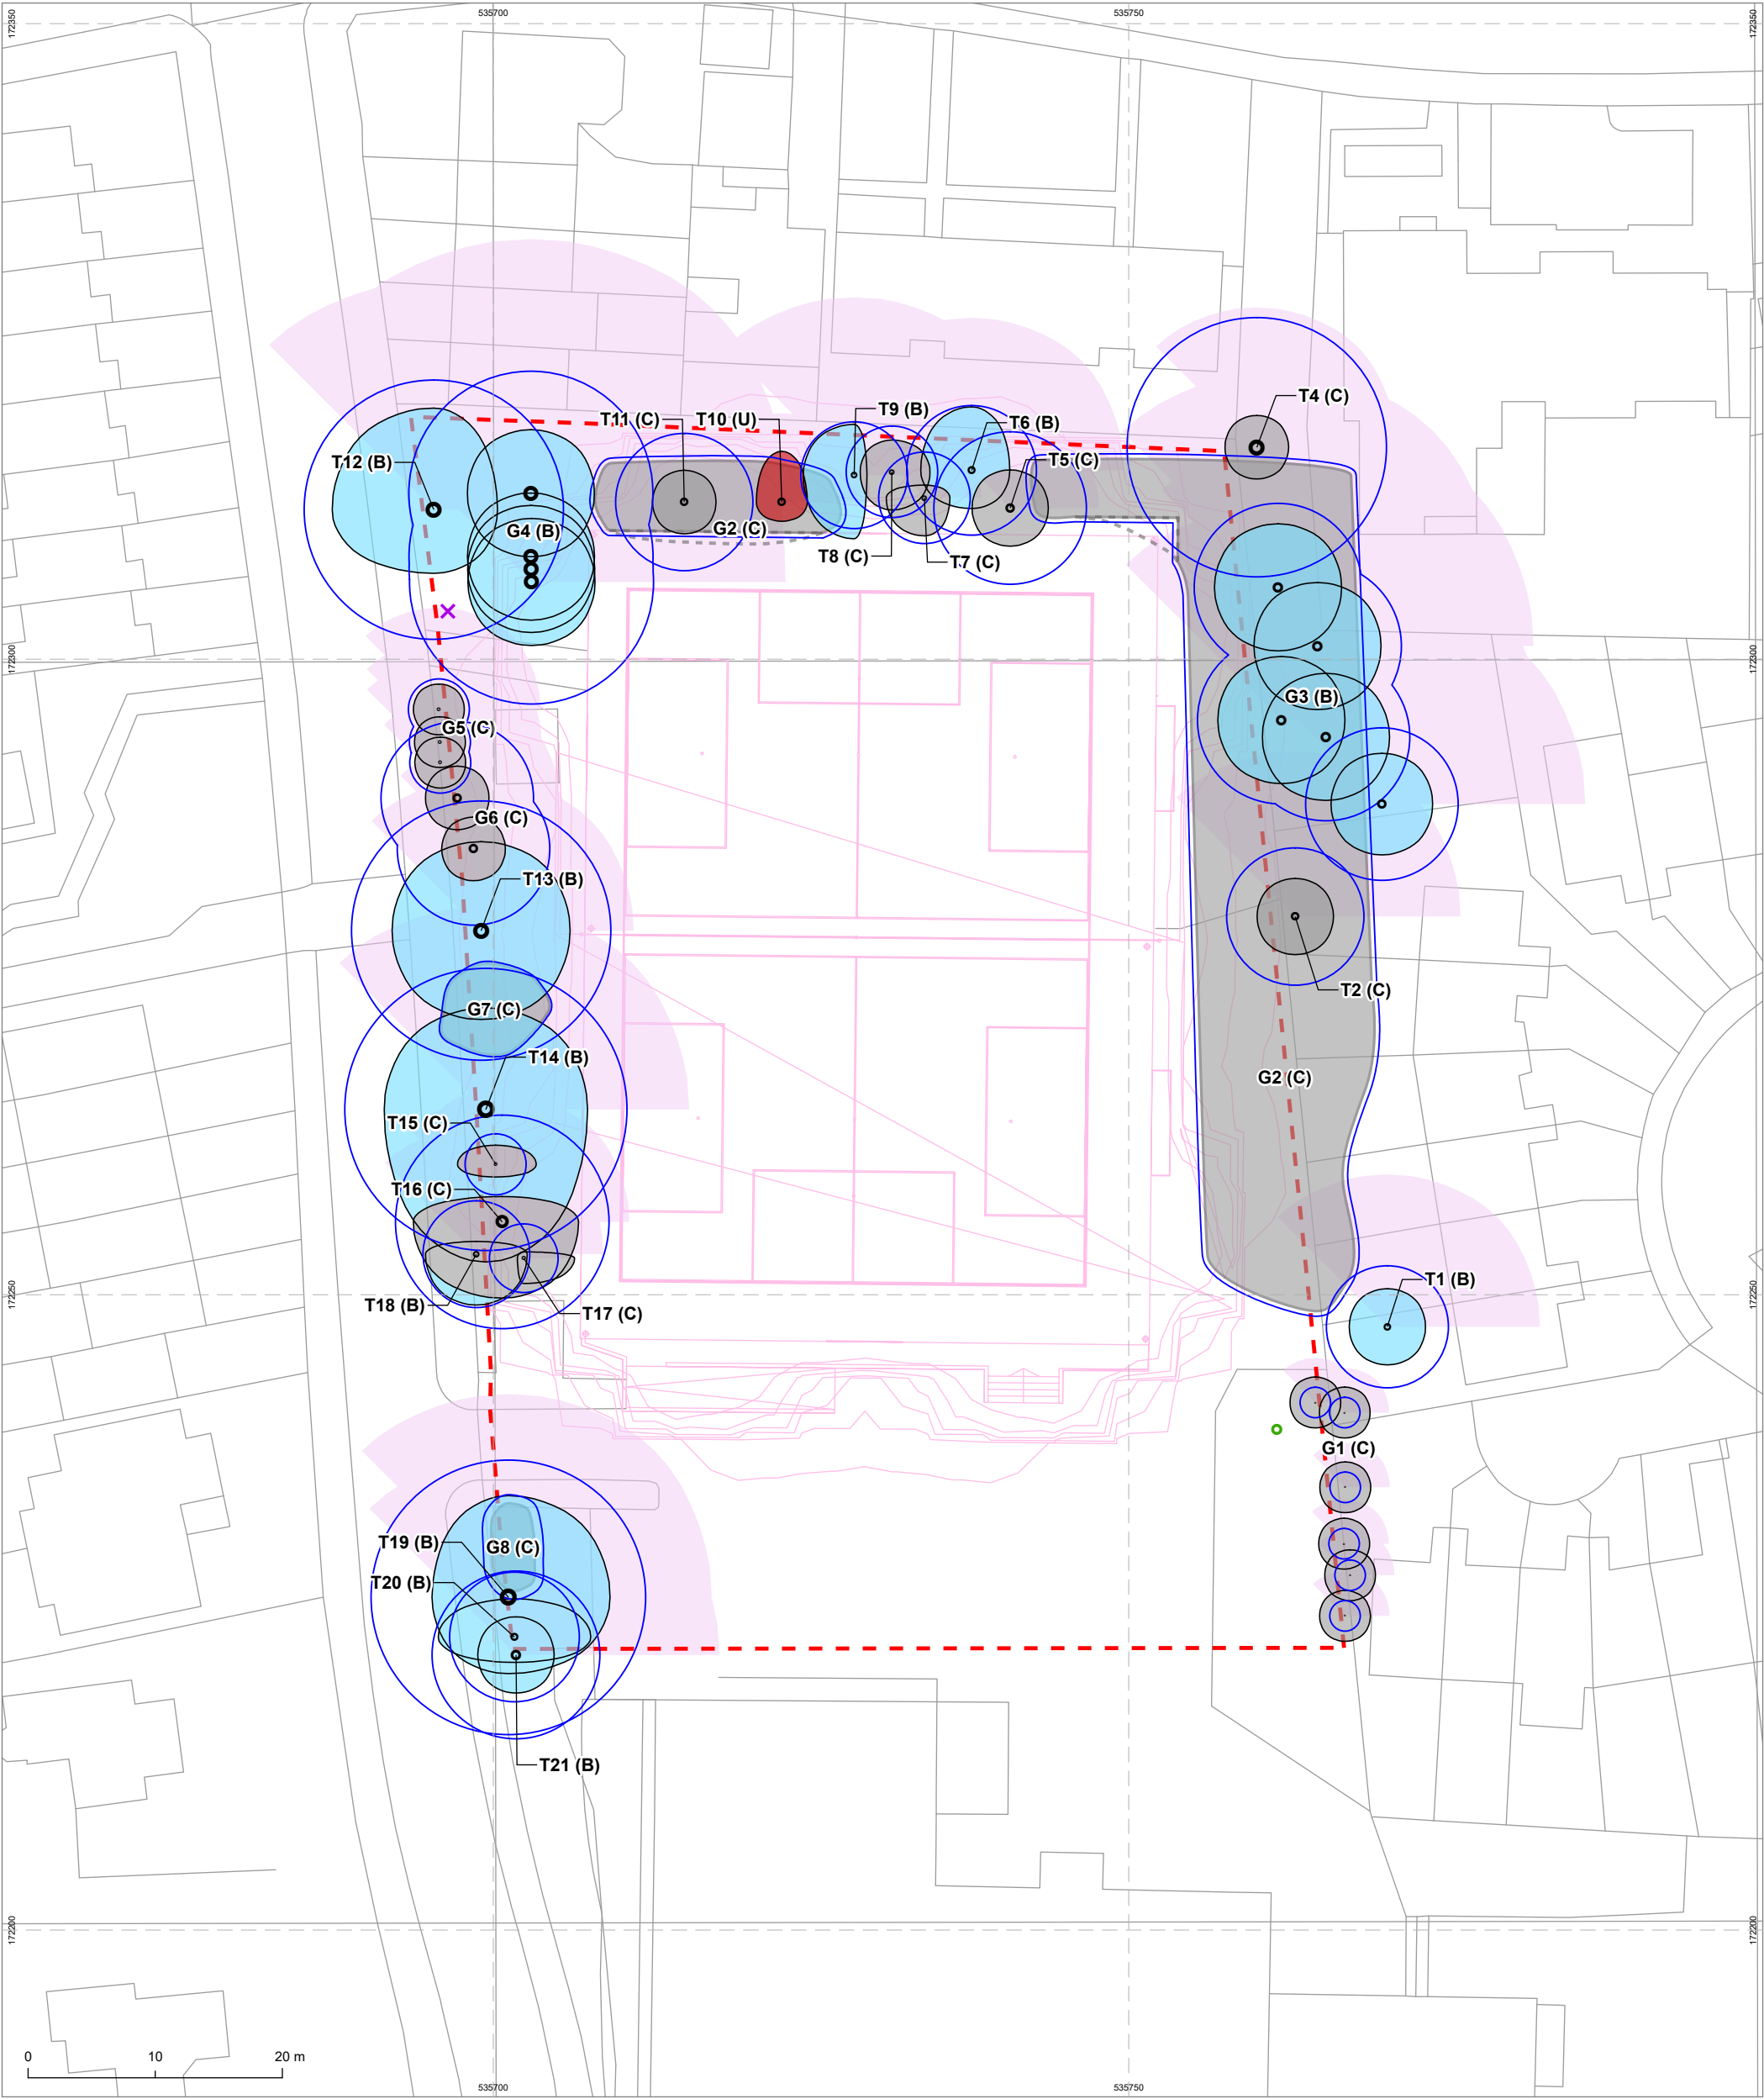
Tree/ Tree Group / Hedgerow Reference	Species	Retention Category	Reason for Removal
G2*	Mixed species	C	To facilitate the construction of the MUGA pitch, level changes for subbase re-formation and a floodlight foundation.
Key *: Partial removal of trees within group or hedgerow

The trees to be removed within group G2 will be minimal and young self-seeded specimens at the periphery of the group, the incomplete topographical drawing means it is not possible to accurately quantify the number of individual trees required to be removed at the time of writing, and it is recommended that the Project Arboriculturist attends site with the project engineer to mark those trees required to be removed at the north east corner to facilitate the ground level changes to ensure no unnecessary tree removal is undertaken.
